# PROCESS WATER TANK LINING RESTORATION

ID: 9667

Process water lining was experiencing corrosion due to erosion.

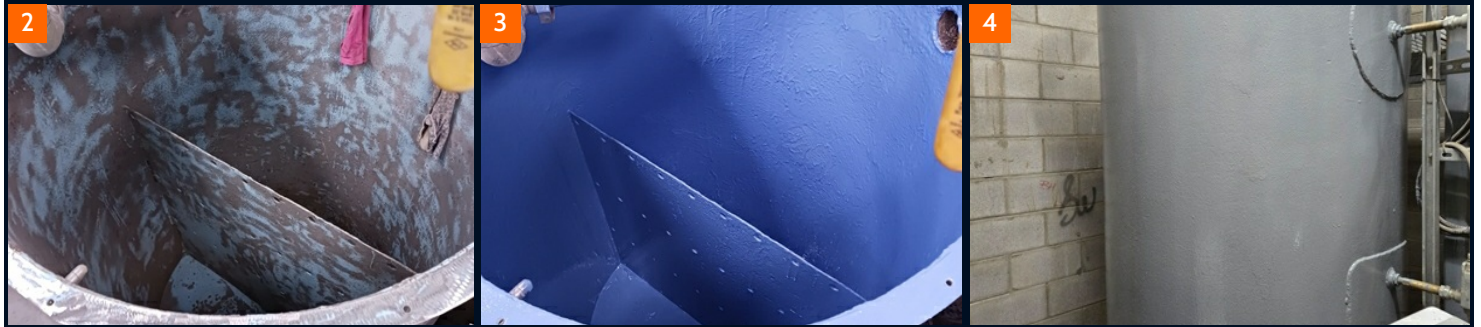
1. Tank before refurbishment.
2. Lining after abrasive blasting.
3. Lining after two coats of Belzona 1341.
4. After application of external coating.

The lining was cleaned to the required level of cleanliness by abrasive blasting and the external by power tool cleaning. The tank was further cleaned and degreased by using Belzona 9111. Two coats application of Belzona 1341 was applied as lining while two coats of Belzona 6111 primer and two coats of Belzona 5111 was applied as coating.
