# BELZONA PREVENTS PLANT SHUTDOWN BY CURTAILING HIGH PRESSURE PIPE LEAK

ID: 9671

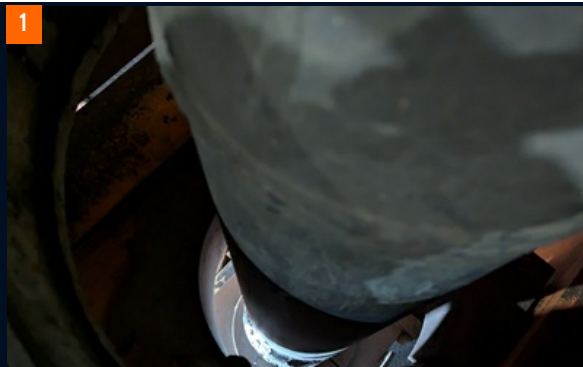
1. Pipe after surface preparation.
2. Pipe and metal plate covered with Belzona 1212.
3. Super Wrap II was installed.
4. Pipe after the application.

The affected area was cleaned to the required level of cleanliness as stated in the products IFU and procedure for repairing leaks in pipes (VPF-11) by abrasive blasting. Belzona 1212 was used to cover both the weld seams and the metal plate before wrapping with Belzona super wrap II kits.
