# HEAT EXCHANGER DIVISION BAR

ID: 9680

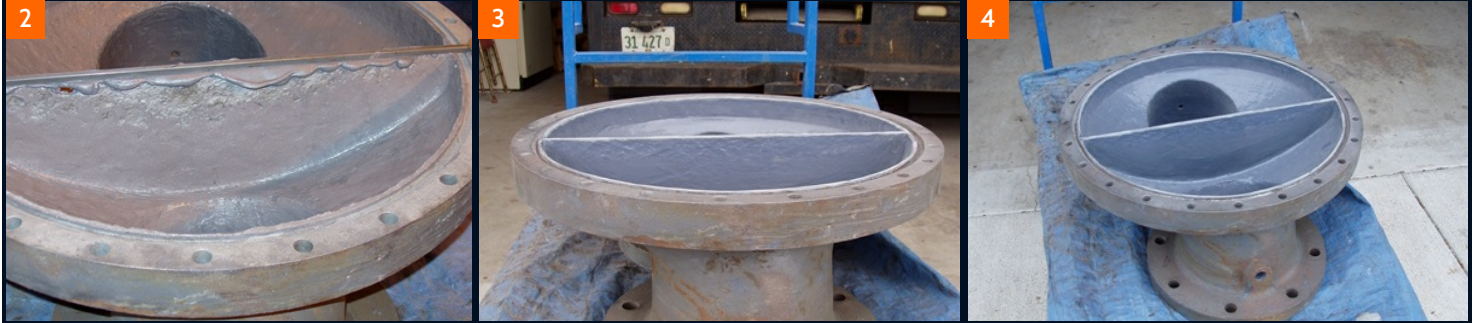
This customer was experiencing severe erosion on their end covers and especially the division bars.

1. The attached image showcases a severely eroded division bar on a heat exchanger end cover. This type of damage compromises the component's performance and efficiency, highlighting the critical need for effective and durable repair solutions.
2. Bar stock serves as a precise former, while Belzona 1311 (Ceramic R-Metal) is expertly applied to restore and rebuild the damaged area to its original strength and integrity.
3. As shown in the attached image, the unit was restored and protected with two coats of Belzona 1321 (Ceramic S-Metal). This durable coating provides exceptional resistance to erosion and corrosion, ensuring the component's long-term performance.

Substrate was blast cleaned to a SSPC-SP 10/NACE No. 2-2024, Near-White Metal Blast Cleaning. Belzona 1311 (Ceramic R-Metal) was generously applied to the damaged division bar. A key stock with Belzona 9411 (Release Agent) was then clamped in place. Excess Belzona 1311 oozed out and was removed. After the 1311 cured, two coats of Belzona 1321 (Ceramic S-Metal) was applied. Indirect heat was applied for a quicker cure.
