# BELZONA STOPS THE CORROSION INSIDE OF A TUNNEL.

ID: 9689

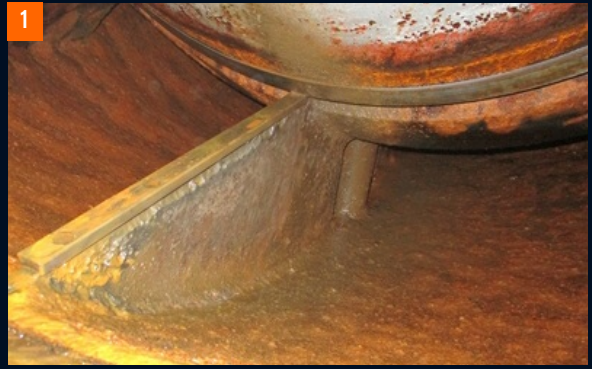
Corrosion on this reservoir valve was getting bad, so a stainless steel runner was attached, which resulted in dissimilar metals corrosion which increased the damage rapidly.

1. Initial inspection, after use of a wire wheel to see the corrosion damage.
2. Grinding for surface preparation.
3. Belzona 1311 applied to the corroded areas and over coated with Belzona 1321.
4. Inspection in May 2017.
