# OIL LEAK IN TRANSFORMER SEALED AT MAJOR POWER DISTRIBUTION FACILITY

ID: 9690

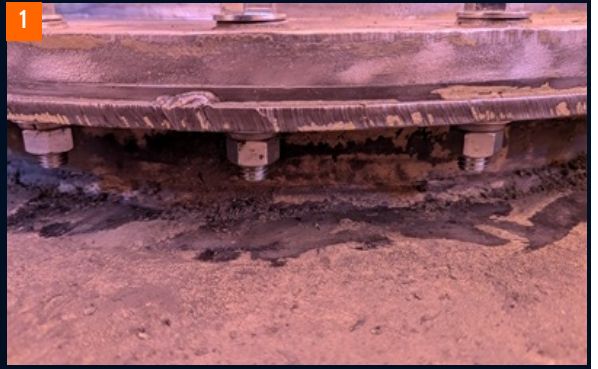
1. Surface preparation of the area.
2. Sealing the leak with Belzona 1161
3. Rebuilding the entire area with Belzona 4141
4. After application of Belzona 5831LT

The oil was lowered a bit and then the surface was degreased as good as possible and abraded to create a rough surface. Belzona 1161 was mixed and applied around the bolts and the flange. Then Belzona 5831LT was applied to seal the entire surface. However, the next morning the customer applied pressure to the system, and they saw a few areas that needed to be reinforced. We decided to pack the whole area with 4141 and then apply 5831LT to encapsulate everything. The system was tested again, and no leaks were found.
