# BELZONA SAVES SALT HOPPER IN A MUNICIPAL FACILITY.

ID: 9694

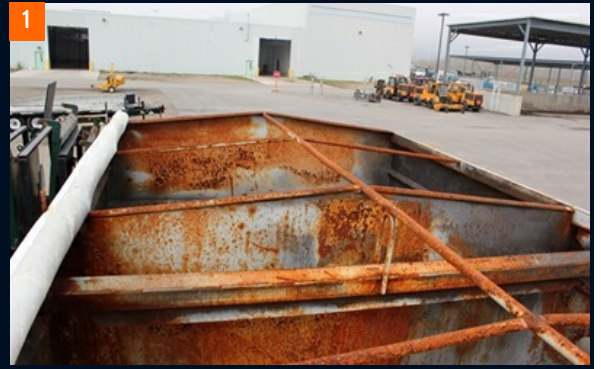
Hopper was experiencing extreme rate of corrosion due to salt contamination and abrasion.

1. Hopper before application.
2. Hopper during Belzona application.
3. Hopper after a year in service.
4. Close view after a year in service.

Hopper was grit blasted to the required level of cleanliness as recommended in the products IFU. After require QA/QC checks, Belzona was applied and post application testing was done for require parameters.

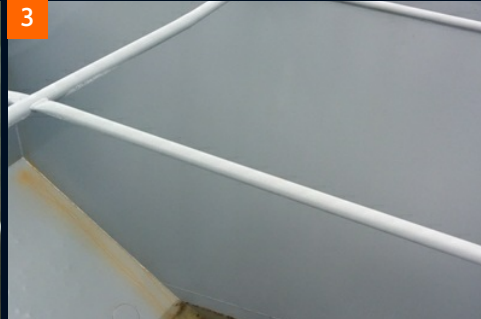
Belzona was able to protect the hopper better than previously used coatings as after a year, hopper still appears in good shape.
