# CONCRETE STAIRS SAVED FROM FURTHER DILAPIDATION.

ID: 9696

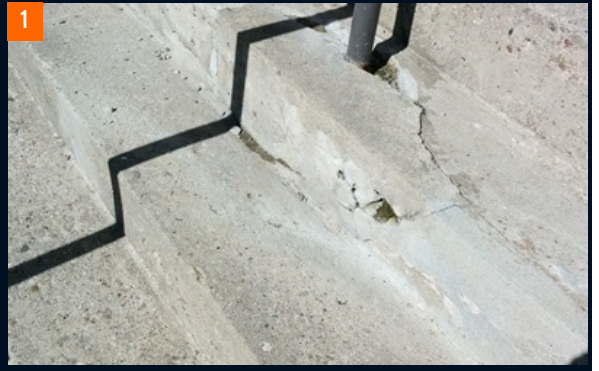
Stairs was experiencing cracks along the railing pillar and was on the verge of falling apart.

1. Cracks on stairs before repair.
2. Further cracks .
3. After surface preparation.
4. Stairs after repair.

The weak parts of the concrete stairs was removed and vacuumed. The areas were subsequently rebuilt with Belzona 4111.
