# PARKING LOT ENTRANCE DAMAGED DUE THE HEAVY TRAFFIC LOAD AND HARSH WEATHER

ID: 9697

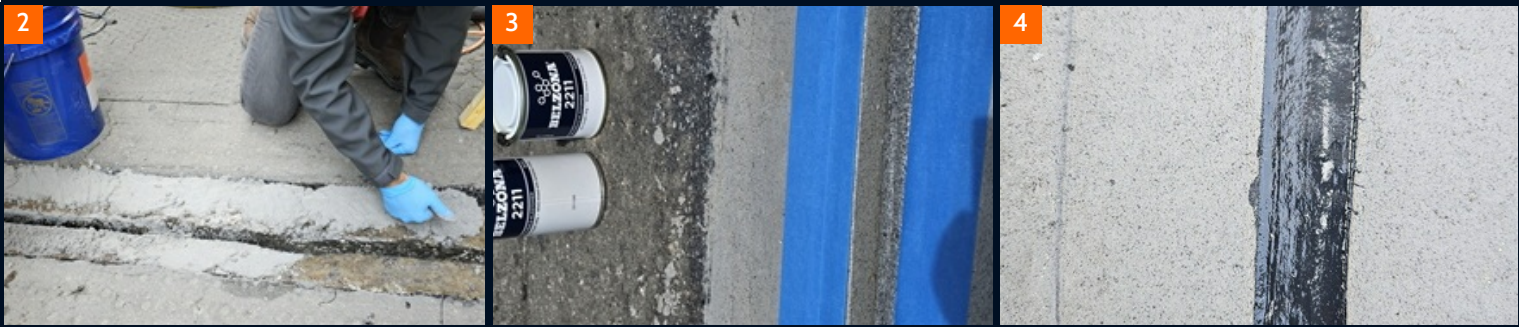
An expansion joint in the parking lot ramp of a large residential building was defective, and the customer sought a permanent solution that would minimize disruption to the daily activities of the building's residents.

1. Parking lot area before repair.
2. Application of Belzona 4911 and Belzona 4111.
3. Area tapped for application of Belzona 2911 and then Belzona 2211.
4. Application completed of Belzona 2211

To minimize disruption to ramp usage, the repair was divided into two phases. One half of the ramp remained open for use while the other half was repaired. Loose concrete was thoroughly cleaned and removed before applying 4911 conditioner. Worn-out areas were then repaired using 4111. Once the 4111 was stable, 2211 was used to fill the expansion joint. After curing, the process was repeated on the remaining half of the ramp, completing the repair.
