# GAYLORD OPRYLAND EXPANSION JOINT

ID: 9699

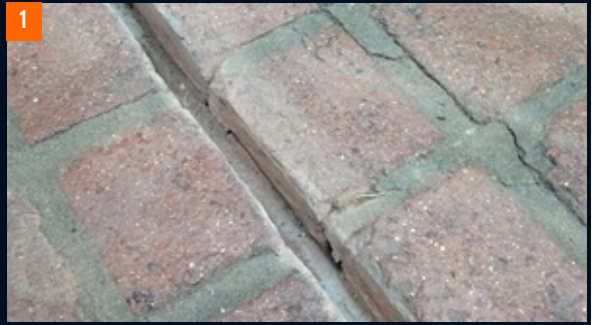
Customer had a failing expansion Joint. It was also a trip hazard.

1. Expansion joint before application
2. Application of Belzona 2211
3. Application completed with Belzona 2211

Old failing joint was removed, and the joint was cleaned out. Tape was used to keep a straight line.
