# BELZONA PROTECTS PAPER MACHINE FILTER

ID: 97

Stainless steel filter on large paper machine

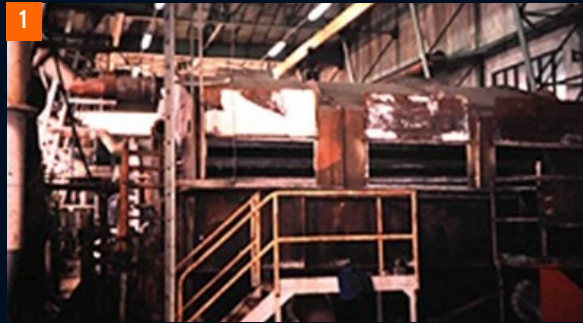
Severe corrosion including some small holes, due to soda concentration in the paper.

1. General view of the filter
2. Application of Belzona 1321 underway
3. Completed application

Application was carried out in accordance with Belzona System Leaflets TCC-1 & TCC-5. Belzona® 1111 used to seal holes before surface protected from further corrosion by coating with Belzona® 1321.
