# TUBE MILLS ARE NO PROBLEM FOR BELZONA

ID: 9701

## PROBLEM

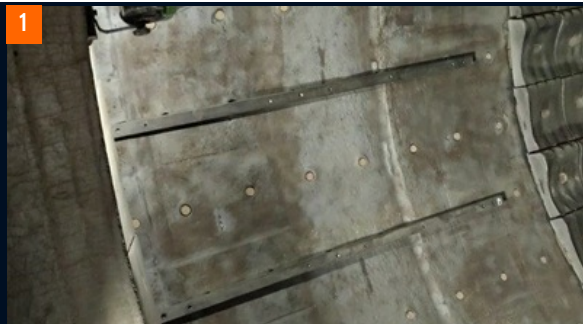
1. Tube mill grit blasted by the customer.
2. The damaged area repaired with Belzona 4111 (Magma-Quartz).
3. Close shot of the application in process.
4. The damaged area half way covered with Belzona 1812 (Ceramic Carbide FP).

The surface to be repaired was grit blasted by the customer. A steel frame was prefabricated so that Belzona 4111 (Magma-Quartz) could be applied at the exact height. Another steel frame with different dimensions was prefabricated so that Belzona 1812 (Ceramic Carbide FP) could be applied at the exact height.
