# AN AUGER IN A CONCRETE PRECAST COMPANY GETS THE BELZONA TREATMENT.

ID: 9702

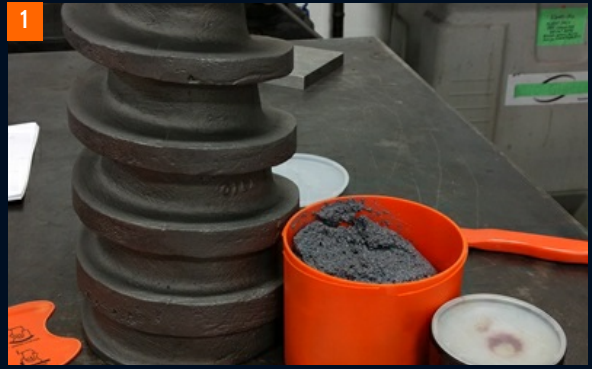
1. Auger after abrasive blasting.
2. Auger during application of Belzona 1812.
3. Application completed with Belzona 1812.

The part was grit blasted to the required level of cleanliness as stipulated on the product's IFU. The vanes were then covered with Belzona 1812 for optimum abrasion resistance.
