# HEAVILY CORRODED AIR HANDLING UNIT NEEDED SOME BELZONA

ID: 9703

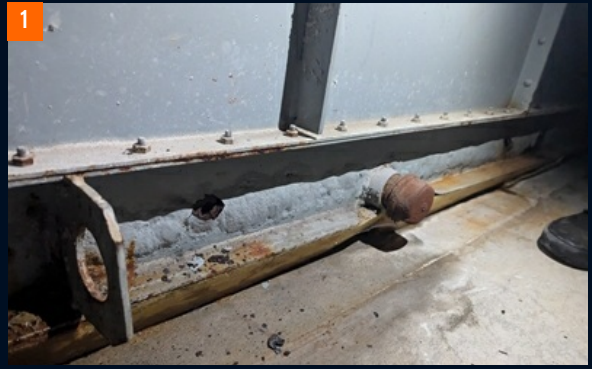
The customer left these units untreated and unprotected for many years, resulting in significant deterioration. Welding was not an option due to the thinness of the remaining metal. As a solution, they decided to entrust us with the repair, aiming to restore and extend the service life of these units.

1. Unit before cleaning.
2. Unit during power tool cleaning.
3. During application of Belzona 1161.
4. Application completed with Belzona 1981 with reinforcement mesh Belzona 9371.

All structurally unsound steel areas were removed, and the entire surface was mechanically roughened to ensure proper adhesion. The removal of rusted steel left several large holes, which were addressed by installing metal reinforcing plates. Belzona 1161 was then applied for bonding and sealing, followed by the use of Belzona 9381 in combination with 9371 fiberglass mesh to provide additional reinforcement and durability.
