# HEAVILY CORRODED AIR HANDLING REFURBISHED WITH BELZONA 5831

ID: 9704

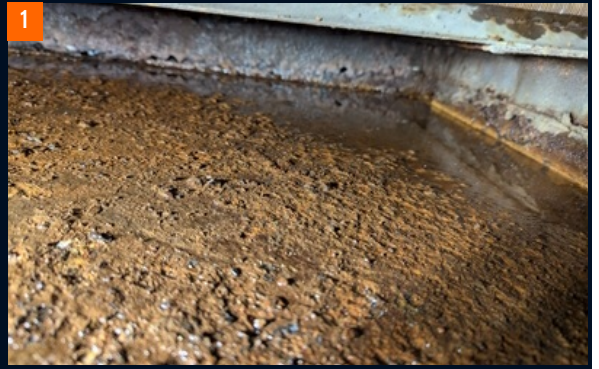
Two air handling units were heavily corroded and leaking in several areas. The whole basin needed to be coated and properly sealed.

1. One of the basins before cleaning.
2. Basin during surface preparation.
3. During application of Belzona 5831
4. Both units after coating application.

All the rusty areas were scrapped and removed with a putty knife followed by power tool cleaning. Then two coats of Belzona 5831 were applied. The system was allowed to cure for 2 days before being put back in service.
