# HOSPITAL DRAIN

ID: 9706

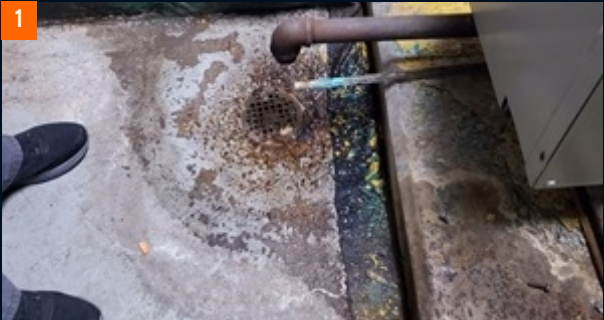
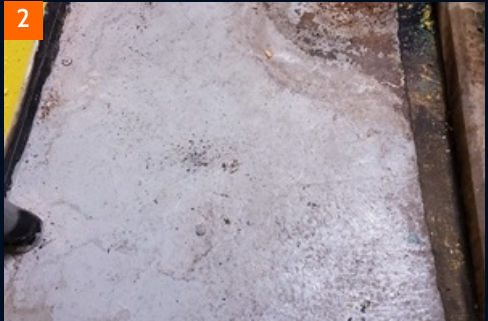
Drain was leaking in patients room.

- 1. Drain condition before repair with Belzona
- 2. Drain condition before repair with Belzona
- 3. Final application of Belzona solution
- 4. Final application of Belzona solution

Concrete was prepared with hand tools and cleaned before doing the repair.

Belzona 4111 (Magma-Quartz)  
Belzona 5231 (SG Laminate)
