# BASF PLATE BOND ON HOPPER

ID: 9707

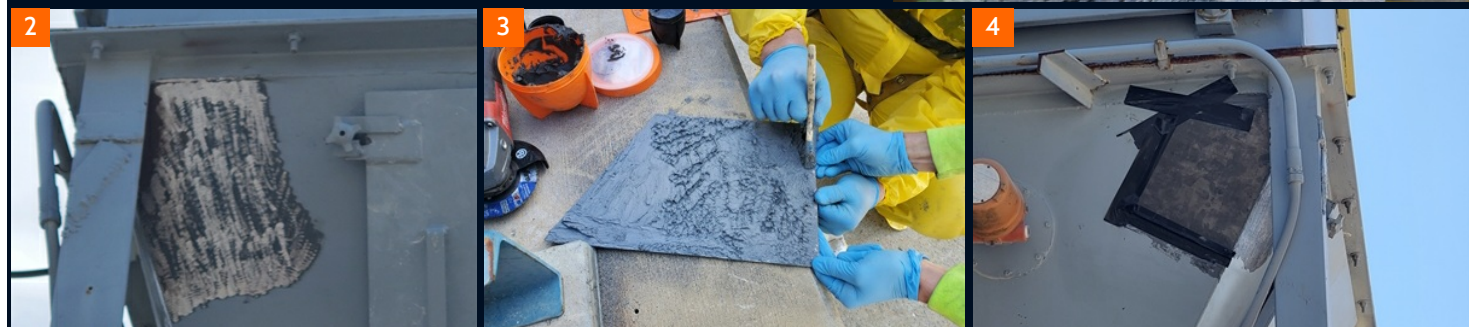
## PHOTOS

Hopper had developed a worn area as was losing product.

1. Surface preparation in the plate
2. Surface preparation in the equipment
3. Application of Belzona 1111 on the plate
4. Plate bonding completed

Plate was cut to size and roughened, and hopper was also prepared using hand tools. Belzona 1111 was applied to both surfaces.
