# CHRIST CHURCH CHILLER TUBE SHEET

ID: 9709

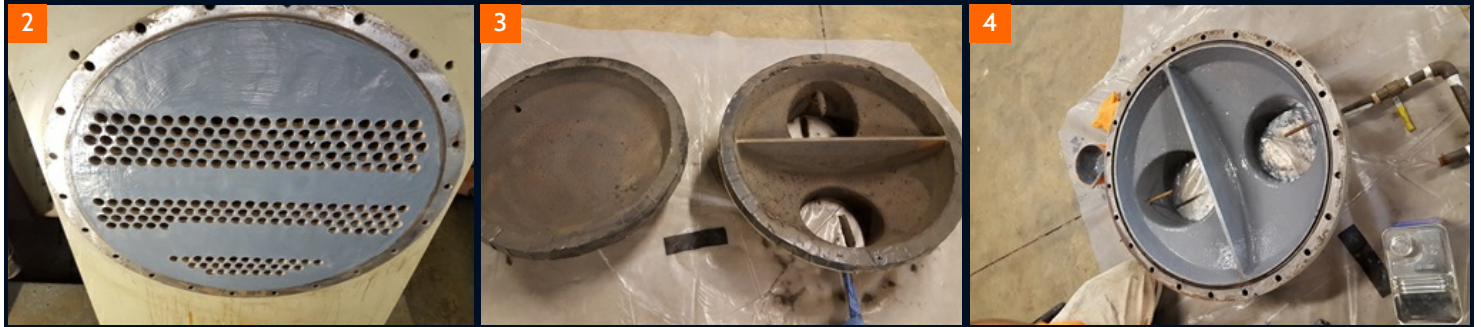
## PHOTOS

Mechanical contractor pulled the heads and covers and discovered the heads were worn and needed to be replaced or repaired.

1. Tube sheet section damaged.
2. Rebuilding and protection completed with Belzona 1121 and Belzona 1321.
3. Ends covers damaged.
4. Protection completed with Belzona 1321.

Mechanical contractors removed the covers then our team blasted the heads and covers. The tube sheet face needed to be rebuilt with Belzona 1121 and coated with 1321. The covers were also coated with Belzona 1321.
