# CHILLER TUBE SHEETS

## 2/400 TON

ID: 9710

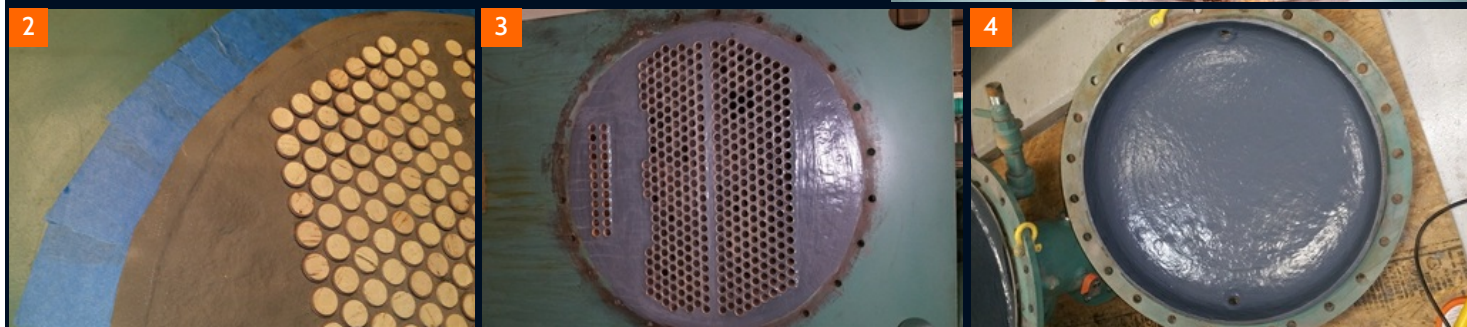
### PHOTOS

Chiller Tube Sheets damaged due to age.

1. Tube sheet section damaged.
2. Preparation for coating application.
3. Rebuilding and protection of the tube sheet with Belzona 1121 and Belzona 1321.
4. Rebuilding and protection of the cover with Belzona 1121 and Belzona 1321.

Mechanical contractor removed the covers our team coked the tubs and blasted the heads and covers. They repaired any needed areas with Belzona 1121 and coated the heads and covers with two coats of Belzona 1321.
