# FRITO LAY SHAFT REPAIR

## PROBLEM

Customer has a shaft that was worn due to bearing failure.

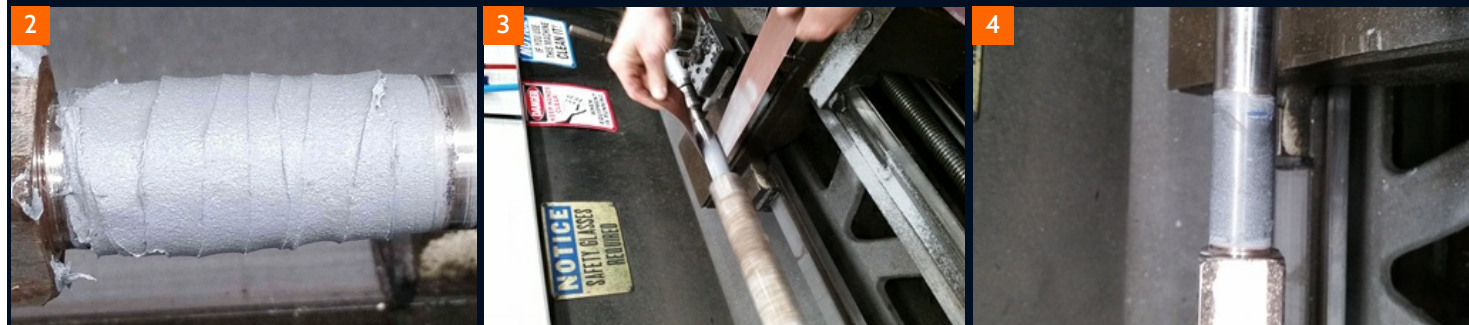
## PHOTOS

1. Shaft was worn out.
2. Application of Belzona 1111
3. Sanding out for final touch of the repair.
4. Application completed

Shaft was prepared and cleaned Belzona 1111 was applied
