# BONNELL SUMP

ID: 9713

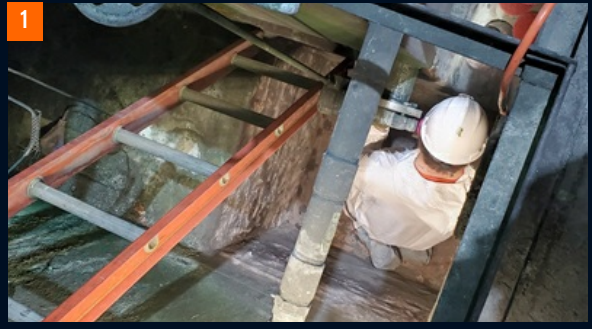
Customer had a leaking sump and damaged concrete.

1. Application area.
2. Application in progress.
3. Completed application.

Contractor has to prepare the concrete and follow guidelines for air quality and confine space. Belzona 4111 was used to rebuild the concrete and Belzona 4341 to provide chemical resistance protection.
