# CONCRETE CHEMICAL TROUGH PROTECTION WITH BELZONA

ID: 9714

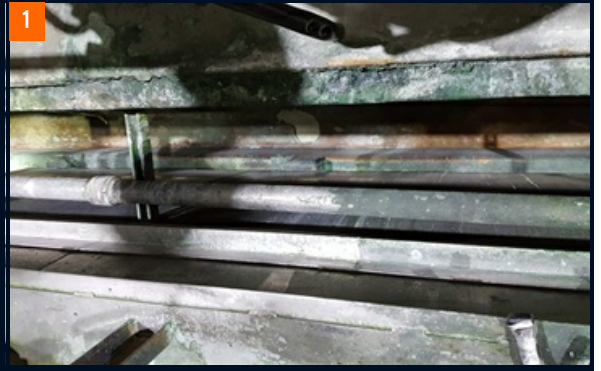
Trough was damaged due to age and acid attack. Customer required a Belzona solution.

1. Overview of repair area.
2. Overview after surface preparation was completed.
3. Application in progress.
4. Completed application.
