# BELZONA NON-SLIP SYSTEM STOPS FALL INCIDENTS

ID: 9716

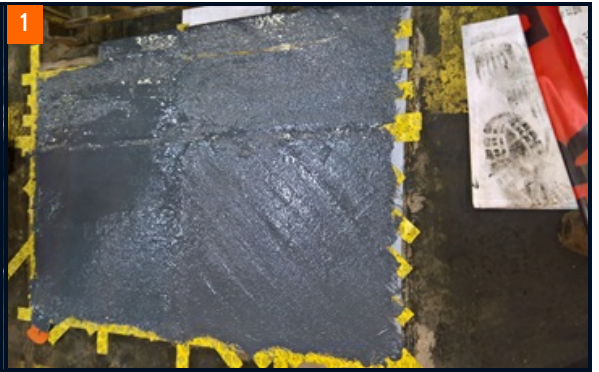
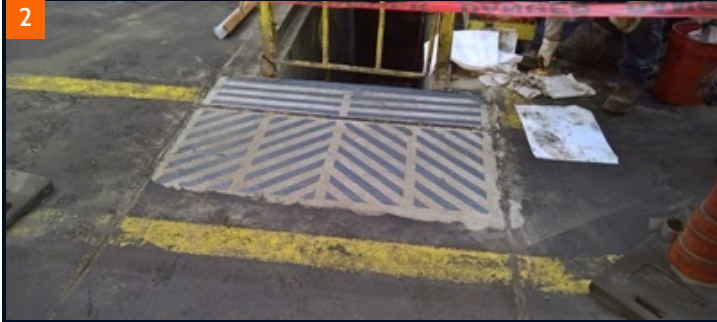
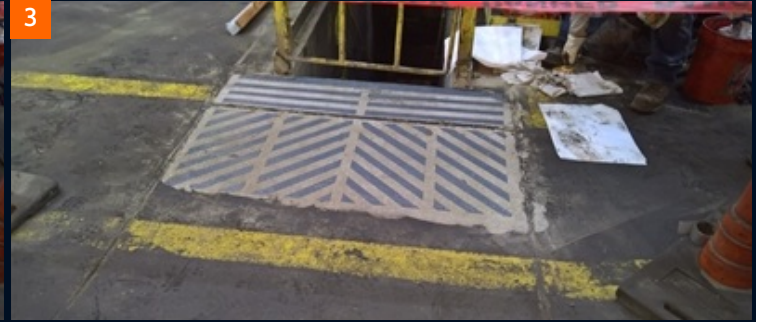
1. Belzona 1321 (Ceramic S-Metal) was applied and Belzona 9211 (Supergrip Aggregate) was incorporated to provide a tenacious non-slip system.
2. The pattern chosen for this application was a "chevron" or "diagonal hatch" design with "parallel striping" closest to the stairs.
3. Finished application.

The concrete surface was prepared using an MBX Bristle Blaster. Then a diagonal hatch design was taped off. A parallel striping design was used at the entrance to the stairs. Belzona 1321 (Ceramic S-Metal) was applied in a single 10 mil coat with Belzona 9211 (Supergrip Aggregate) incorporated.
