# BELZONA REPAIRS STEPS AT CIVIC CENTER AUDITORIUM IN 1984. 40 YEARS LATER THE BELZONA REPAIR IS HOLDING STRONG.

ID: 9717

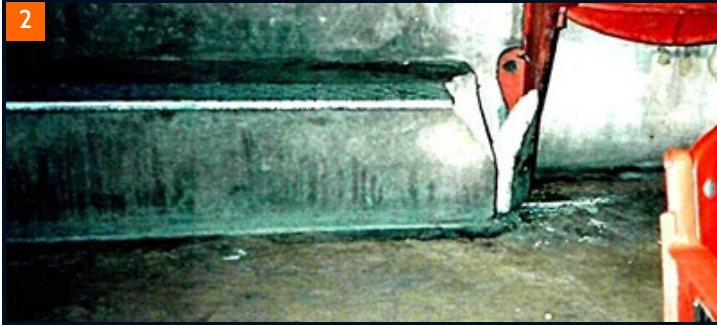
The nose tread on the concrete steps have a metal plate. Over the years, expansion and contraction of the metal plate broke off the concrete end pieces. This problem became a safety issue for trip / fall risk.

1. Overview of the Savannah Civic Center Auditorium.
2. Overview of the 1984 Civic Center Spalled Steps.
3. Savannah Civic Center Repaired with Belzona 4111.

In 1984, Jim Lynch with DBR Associates sold and applied the BELZONA products. The spalled concrete was removed and the concrete was wired brushed. Holes were drilled in the spalled concrete area and two or more 3" bolts were installed within the spalled areas to insure torsional rigidity. The spalled area was cleaned and the BELZONA 4911 (Magma TX Conditioner) applied to the area to be repaired. Plywood forms were placed on the sides of the steps and held in place with duct tape. BELZONA 4111 (High Performance Concrete Repair and Rebuild Composite) was applied by trowel and beveled where the metal nose tread met the repaired area allowing for expansion and contraction.

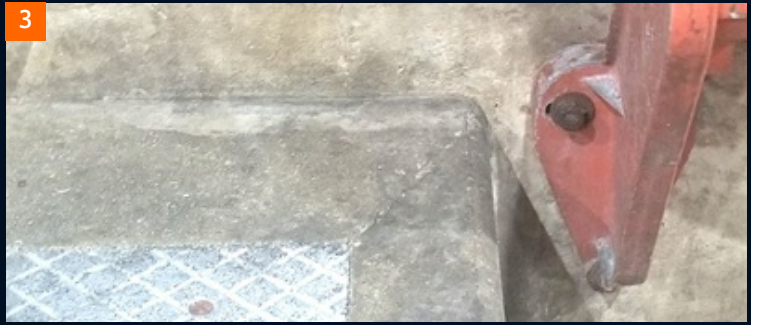
Inspection after 40 years revealed the BELZONA repair to be in good condition and no wear on BELZONA 4111 repair areas.
