# PUMP SHAFT REPAIR

ID: 9718

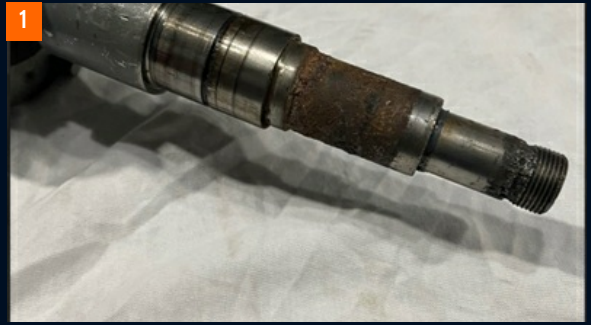
One of the pump shafts in the machinery shop showed damage near the sealing area. Following our initial consultation, they ask for guidance on how to fix it without having to replace it. Because of its self-lubricating qualities, Belzona Bearing Metal 1131 was recommended.

1. Shaft Initial Condition
2. Surface prepared
3. Bearing Metal Application
4. Complete repair
