# BELZONA SAVES AUTOMATED EQUIPMENT REPAIRS BY REBUILDING EXPANSION JOINTS

ID: 9719

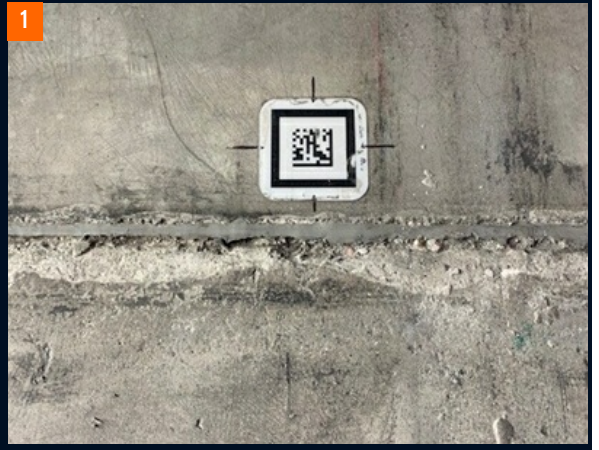
The 900,000-square-foot distribution center faced escalating maintenance costs as automated picking equipment endured constant wear from damaged expansion joints, creating uneven surfaces that led to bearing and other mechanical damage.

1. Close up of the damaged expansion joint. Most of the facility's expansion joints resembled this.
2. Area was prepped and taped off for a clean application
3. This "smooth ride" expansion joint will provide decades of service and minimize damage to the facility's equipment.

The damaged expansion joint was saw-cut, and the concrete surface was prepared using an MBX Bristle Blaster. After taping off the area, Belzona 4911 (TX Conditioner) was applied to the substrate with a stippling technique. Belzona 4511 (Magma-Flex Hi-Build) was then mixed and installed as per the Instructions for Use. The tape was removed, and the area was ready for service the following day.
