# BELZONA IN-SITU TANK REPAIR

ID: 972

Paint booth process water tank

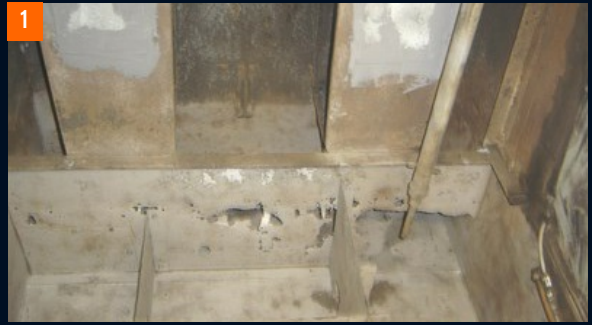
Corrosion and leaking tank. To replace tank with new was costly and would result in production downtime of 7-10 working days.

1. Tank cleaned and shot blasted
2. Vacuum column prior to plate being bonded
3. Remedial work/plates bonded in place
4. Tank complete after 2 coats of Belzona 5811

Application was carried out in accordance with Belzona Know-How System Leaflets TCC-1 & -3. doubler plates were bonded over perforated steelwork before applying corrosion resistant coating.
