# MUNICIPALITY SAVES MONEY BY COATING PUMPS WITH BELZONA

ID: 9720

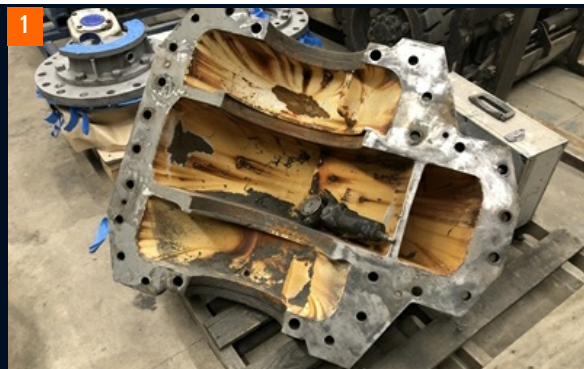
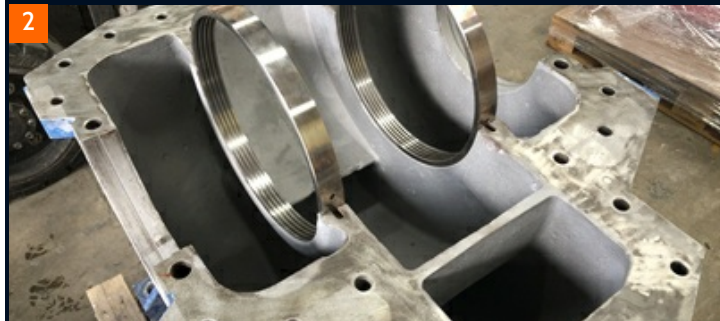
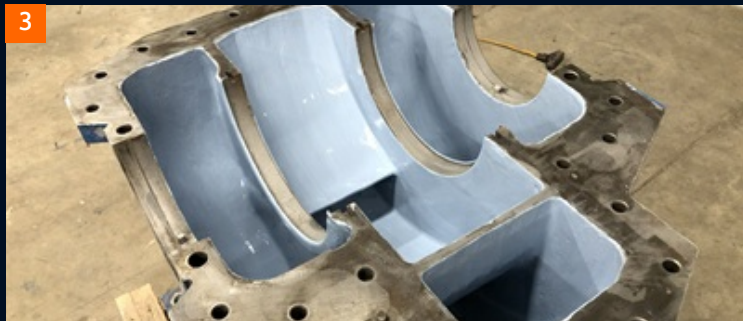
1. Condition of pump casing when pulled from service.
2. Pump grit blasted and new wear rings positioned.
3. Finished application with the wear rings rebuilt and the pump casing coated with Belzona 1341N (Supermetalgilde).

To replace this pump was upwards of \$35,000 in 1998 dollars. Belzona was able to rebuild the wear rings, cutwater and apply two coats of their energy efficiency coating and return this pump to service in a few days. The replacement part was going to take more than six months to obtain.

Pump was grit blasted then degreased using Belzona 9111 (Cleaner/Degreaser). Wear rings were cast and cutwater was formed using Belzona 1311 (Ceramic R-Metal). Then one coat of Belzona 1321 (Ceramic S-Metal) was applied followed by two coats of Belzona 1341N (Supermetalgilde).
