# ENGINE ROOM CORROSION REPAIR

ID: 9722

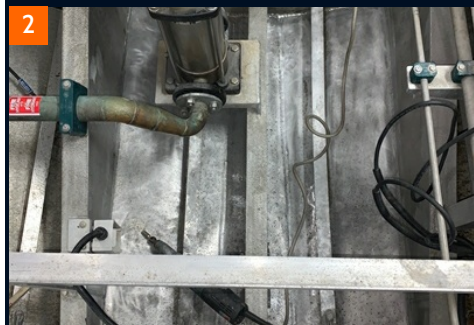
1. Engine room flooring to be repaired.
2. Surface preparation carried out using handheld power tools due to confined space.
3. Ferrie engine room proved to be a difficult application due to confined space.
4. Belzona 5831 coated carried out successfully.

Due to the confined space of the repair area, hand held power tools were required to carry out the surface preparation. Once complete, 2 coats of Belzona 5811 was applied achieving a 500 micron film thickness. A very successful and straight forward application overall.
