# FERRY CAPSTAN WINCH REBUILT WITH BELZONA 1111

ID: 9724

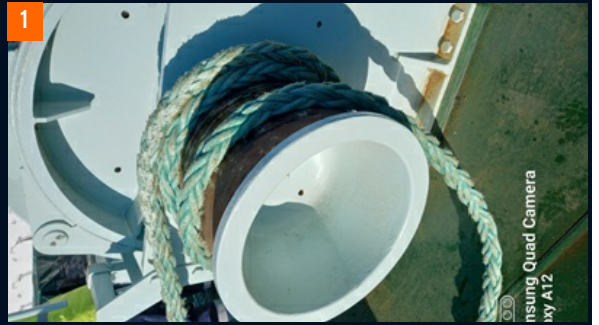
A capstan used for hauling mooring ropes was over coiling due to an insufficient chamfer. Build up using weld overlay would be prohibitively expensive & time consuming within the timeframe available.

1. Ropes overcoiling
2. Grit blast surface preparation
3. Wetting out the surface
4. Build up of Belzona 1111
