# WATER DISTRICT REBUILDS PUMP PACKING GLANDS WITH BELZONA

ID: 9726

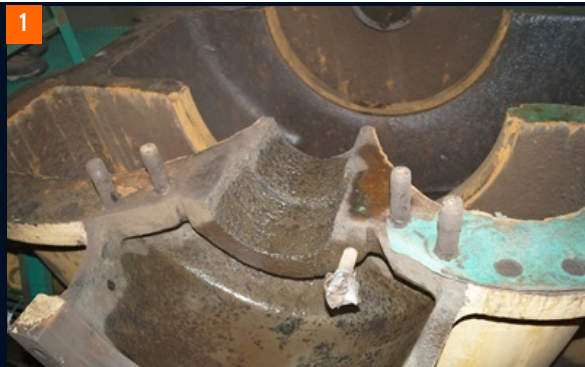
These 100 year old pumps are experiencing corrosion in the packing gland housings that is causing damage to the rotating equipment.

1. Picture of the pitting corrosion.
2. Belzona 1311 (Ceramic R-Metal) applied after proper surface prep was achieved.
3. Lowering the upper casing into place to cast the Belzona. Since this is a 100% solids, no VOCs product whatever we cast to will be the final dimension.
4. Packing gland cast in place and left to cure overnight.
