# BELZONA COATING NETS AN INCREASE OF 700 GPM ON WATER MUNICIPALITY PUMP

ID: 9729

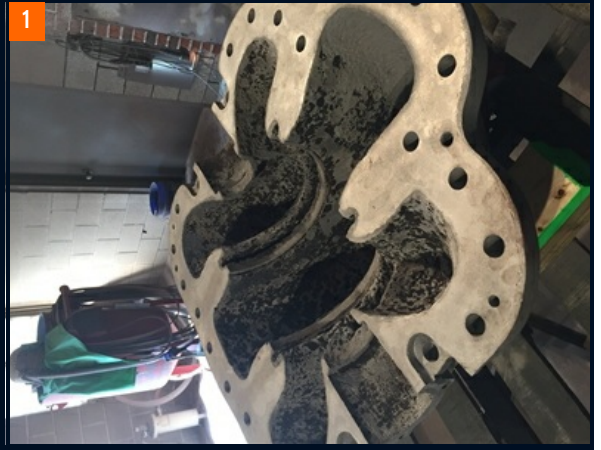
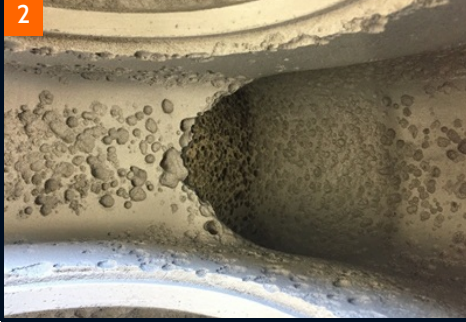
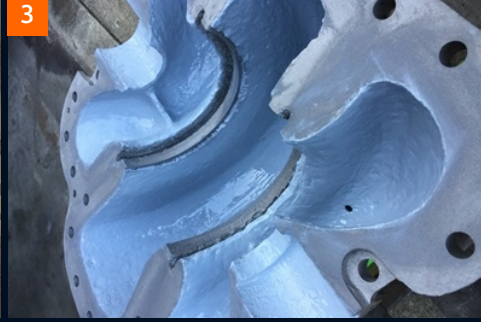
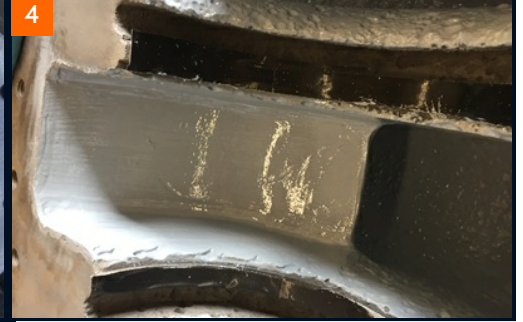
1. Serious corrosion impacted efficiency. The wear rings were rebuilt also.
2. Cutwater was severely eroded.
3. Picture shows completed application of Belzona 1341 (Supermetalgilde) on the top half of the casing.
4. This picture shows the cutwater and wear rings rebuilt and coated.

This pump was grit blasted to SSPC SP 10 near white finish. The cutwater was rebuilt by tack welding expanded metal and then using Belzona 1311 (Ceramic R-Metal) to reform it. The wear ring seats were rebuilt using Belzona 1311 (Ceramic R-Metal) and using new wear rings that were coated with Belzona 9411 (Release Agent) as formers. After these repairs were properly cured, two 10-mil coats of Belzona 1341N (Supermetalgilde) was applied.

Test results after the application of Belzona included a gain of 700 gpm and 3% of wire-to-water efficiency. Anytime this municipality orders a new pump they require it to be coated with Belzona at the point of manufacture.
