# IN SITU SHAFT REPAIR WITH BELZONA

ID: 973

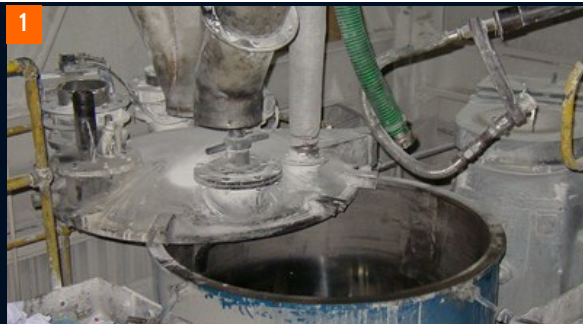
Mixer Vessel drive shaft

1. Mixer Vessel
2. Failed Metal Sprayed Shaft
3. Form tool in position
4. Finished Shaft

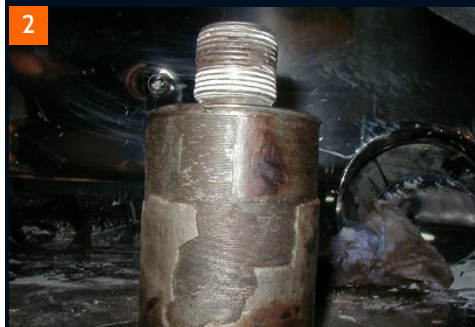
Customer had un-scheduled failure of mixer vessel drive shaft which had previously been repaired using metal spraying.

Old metal sprayed material was totally removed and shaft rebuilt using Belzona System Leaflet MPT-2. Former was made to allow repair to be completed in-situ.
