# DISTRESSED WATER PUMP REBUILT AND COATED WITH BELZONA 1341N HYDROPHOBIC COATING

ID: 9731

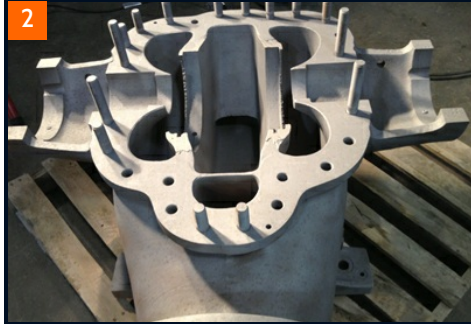
1. General damage to the pump casing, wear ring areas, and packing areas.
2. Grit blasted completed and ready for Belzona application.
3. After the wear rings and packing areas were rebuilt with Belzona 1311 (Ceramic R-Metal) the first coat of Belzona 1321 (Ceramic S-Metal) was applied.
4. Two coats of Belzona 1341N (Supermetalgilde) were applied. Pump is ready to be reassembled.
