# BRINE HEAT EXCHANGER TUBE FACE REFURBISHMENT

ID: 9733

## PROBLEM

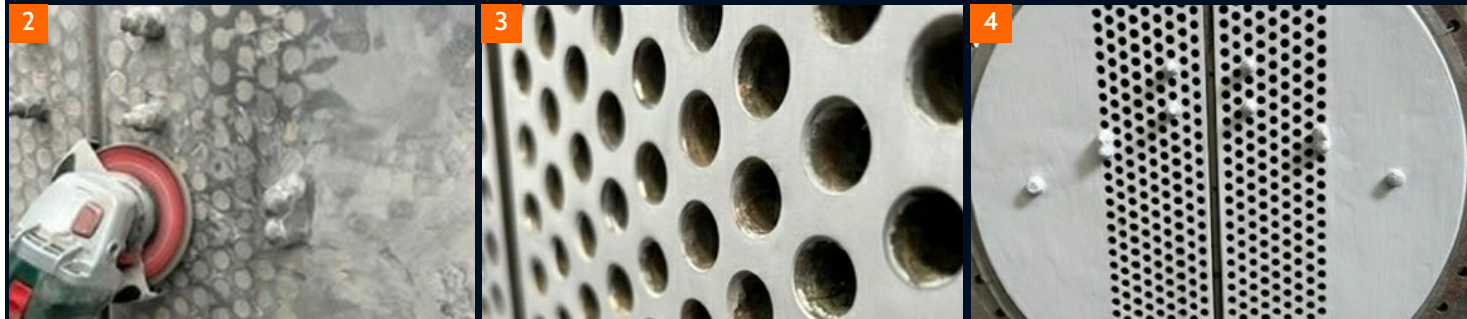
The tube face had suffered severe galvanic and pitting corrosion and the separator channels and tube face needed to be rebuilt to prevent bypass of the separator plate. In addition, the client required a lining to prevent further attack to the tube face.

1. Pitting damage after grit blasting.
2. Belzona 1511 rebuild being profiled.
3. Belzona 1593 application with new tube profile.
4. Belzona 1593 application complete.

After removing the existing coating, soluble salts were removed from all surfaces prior to starting the Belzona application. Surfaces were then rebuilt using Belzona 1511, before applying the high temperature coating Belzona 1593.

Belzona 1511 is a high temperature resistant paste grade and was used to rebuild metal loss and resurface the pitted areas.

All parts of the heat exchanger were then protected with a simple brush application of Belzona 1593 which is capable of withstanding immersion conditions of 160°C.
