# BRINE HEAT EXCHANGER WATER BOX REFURBISHMENT

ID: 9734

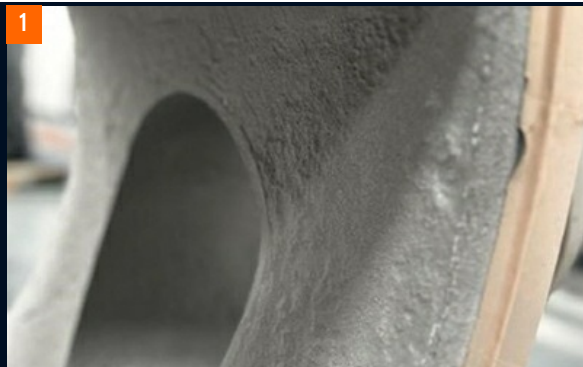
The water box had suffered pitting corrosion and needed resurfacing. In addition, the client required a lining to prevent further attack to the tube face, water box and cover.

1. Pitting damage of Water Box after grit blasting.
2. Belzona 1593 application first coat.
3. Belzona 1593 application completed.

After removing the existing coating, soluble salts were removed from all surfaces prior to starting the Belzona application. Surfaces were then rebuilt using Belzona 1511, before applying the high temperature coating Belzona 1593.

Belzona 1511 is a high temperature resistant paste grade and was used to rebuild metal loss and resurface the pitted areas.
