# BELZONA REPAIRS SCORED SHAFT ON A VALVE

ID: 9735

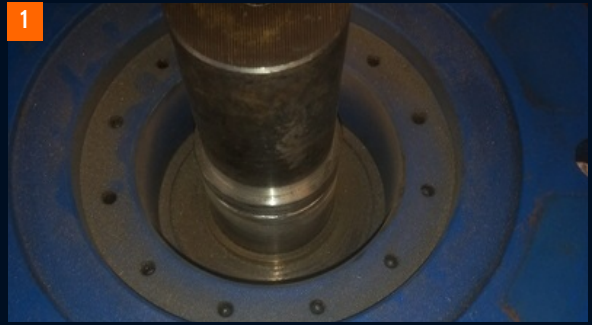
A small hydroelectric plant owned by the local water authority had a series of gate valves. One had a score on a shaft used to actuate the valve. This score was forming a leak path.

1. Surface preparation
2. Belzona 1212 application
3. Dressing down repair
4. Completed repair

The score was first ground out using a pencil grinder. It was also heated to remove any oil within the substrate. Belzona 1212 was then applied & overbuilt by ~2mm. The product was then dressed down smooth with the shaft surface.
