# BELZONA SUPERWRAP II ABS APPROVED SYSTEM REPAIRS LEAK USNS TIPPECANOE

ID: 9738

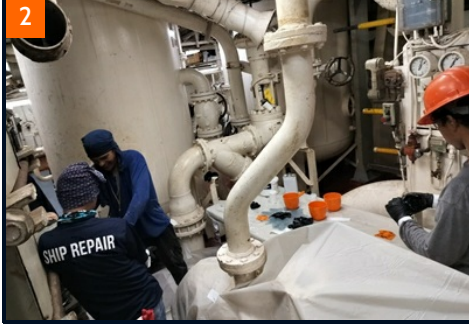
The vessel was at the Guam Naval Base. There are copper-nickel pipes that run cooling water into the main motors. One of the main pipes had already a pin hole from thin wall on the pipe. The only other options were to replace the pipe section but this was not a realistic option because of access and because it would excessively extend the time on dry dock.

1. USNS Tippecanoe
2. Work and access area for repair
3. SuperWrap II being applied on the pipe section
4. SuperWrap II pipe section being finished.
