# BELZONA SOLUTION FOR REBUILDING AND COATING OF STUFFING BOX

ID: 9740

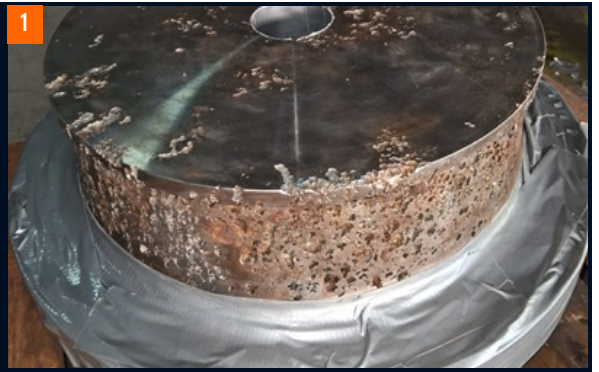
The stuffing box of the pump experienced erosion and corrosion, leading to pitting damage on the internal surfaces and impacting performance.

1. Severely corroded equipment.
2. During the rebuilding works using Belzona 1121.
3. Re-built stuffing box after the application of Belzona 1121.
4. Final equipment after the Belzona 1321 application.
