# SCRAPPED PUMP BROUGHT BACK TO LIFE WITH BELZONA

ID: 9743

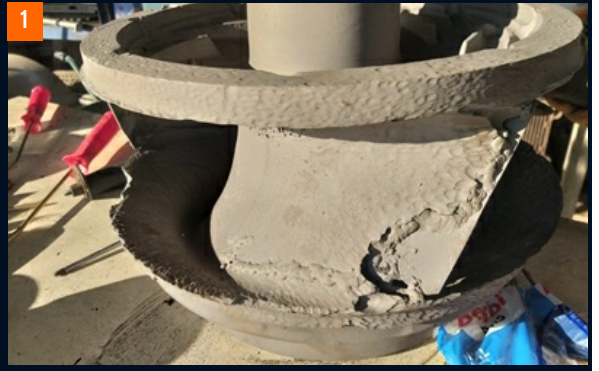
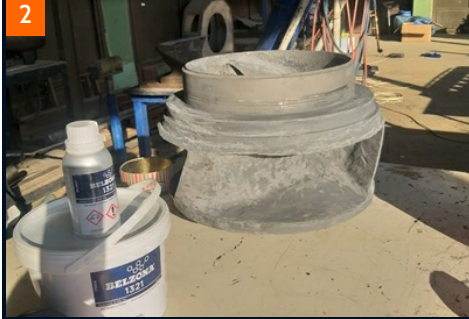
1. Before application
2. Before application
3. After application
4. After application

Surface losses resulting from erosion experienced in the impeller of the sludge pump used in the wastewater treatment plant.

In a wastewater treatment facility, a sludge pump suffered significant erosion on its impeller, leading to severe surface loss.

Application was carried out in accordance with Belzona Know-How System Leaflets CEP-3 & CEP-5.

Belzona 1311 (Ceramic R-Metal)  
Belzona 1321 (Ceramic S-Metal)

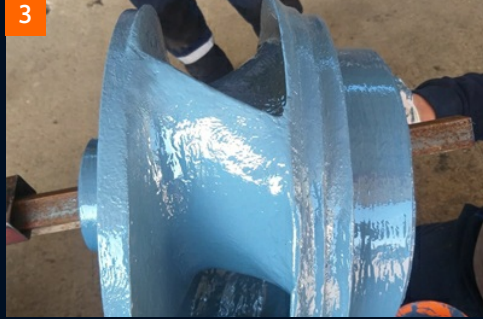
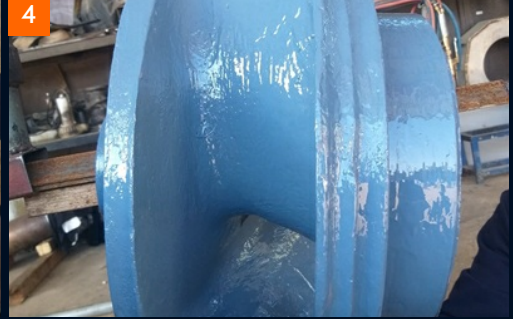
The customer was planning to scrap the pump that had sustained serious damage due to erosion. Following technical meetings, it was indicated that this pump could be returned to service using Belzona products, and the customer was convinced. The customer was very satisfied with the outcome of the application.
