# ANCHOR HANDLING TUG IN NEED OF CRITICAL PIPING REPAIR

ID: 9744

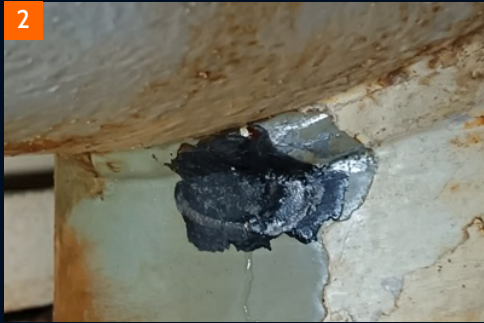
Client was experiencing a through wall defect in critical seawater cooling piping, and could not come alongside for repairs, as they were engaged in a towing operation, transporting an oilfield jacket on a barge to its location offshore Angola.

1. The vessel was engaged on a tow of an oil production platform, where time was a critical factor, and due the size and complexity of the towing assignment, it would have been very difficult to cease operations to install replacement piping.
2. Defective area. Through wall defect, and suspected surrounding thin wall piping.
3. Surface preparation to SSPC-SP11 by means of Bristle Blaster power tools.
4. Repair extended to reinforce the suspected thin wall condition of the pipe spool.

Surfaces were prepared to bare steel with a profile using Bristle Blasters, achieving SSPC-SP11 cleanliness standard. The through wall defect was stopped by the application of Belzona 9611. Belzona 1212 was then applied onto Belzona 9341 Reinforcing Sheet, and applied to the surfaces of the pipe to reinforce and strengthen the suspected surrounding thin wall pipe. A second layer of Belzona 1212 was then applied for additional reinforcement.
