# BELZONA RESTORES WATERSLIDE TOWER AT LOCAL SWIMMING POOL

ID: 9748

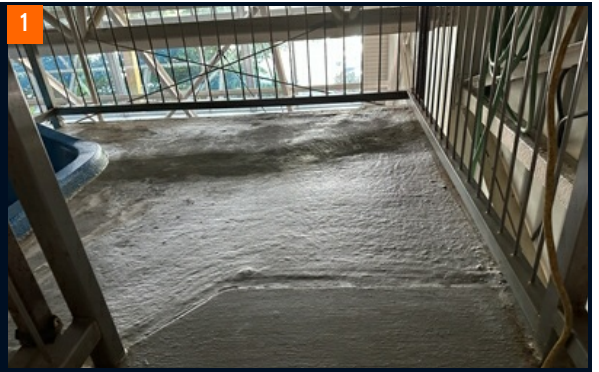
The connecting points between the concrete deck, fiberglass slide and aluminum stairs had all failed. Water was leaking between causing significant corrosion of the Waterslide tower structure

1. Current state of waterslide tower platform. The current coating systems had failed and water was passing through the concrete corroding the steel tower structure
2. Sealing between the fiberglass slides and platform was needed
3. Completed application near slide tops
4. Finished application

All areas were prepared using diamond cup grinders. The area was masked and repairs / resurfacing was completed using Belzona 4111 Magma Quartz. The area was then coated with 2 coats of Belzona 5231 SG Laminate.
