# BELZONA REPAIRS EBONITE COVERED CARPET ROLL

ID: 975

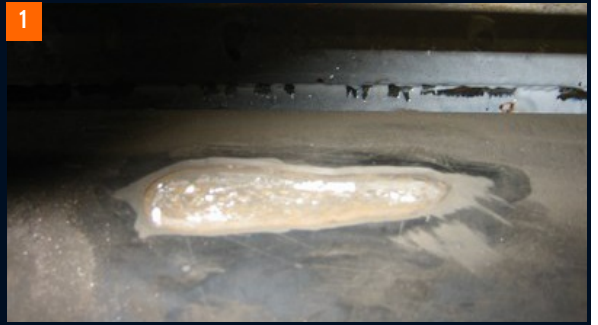
The ebonite had suffered from localised wear and was not readily repairable. In fact the original manufacturer did not recommend repair of this material

1. Roll showing area of missing Ebonite
2. Two damaged areas, the left side prepared the right yet to be prepared
3. The two areas brought back to profile with Belzona 1111
4. The Latex Applicator back in action

Application was carried out in accordance with a modified version of Belzona Know-How System TCC-3. Ebonite was cut back to a sound edge and after roughening exposed steel and surrounding Ebonite, Belzona® 1111 was applied and then finished to profile using a template cut from a Belzona Mixing Board.

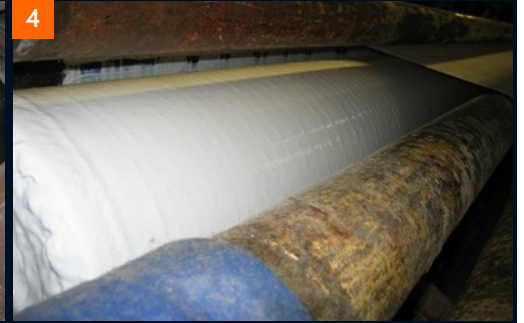
This ebonite covered roll on the Carpet Loom supports the carpet as it passes over the Latex Applicator Roll that coats the back of the Carpet with latex.
