# FLANGE FACE REBUILDING WITH BELZONA 1111

ID: 9750

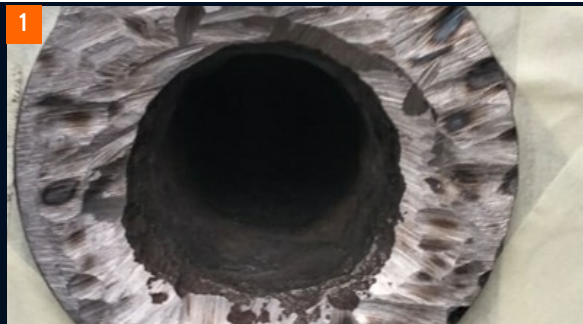
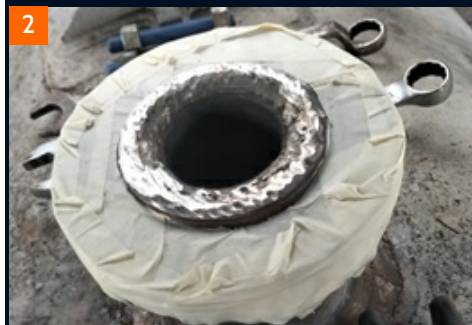
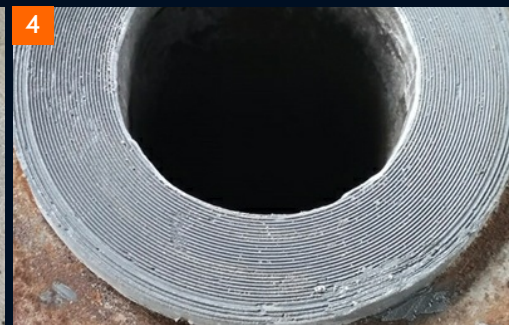
The customer was face loss of metal due to wear over the flange face

1. Surface preparation is done over the flange face before the rebuilding
2. Surface preparation with power tools to prepare the surface
3. Final stage after rebuilding using a former
4. After the former removal, the final stage of rebuilding

We used power tools for surface preparation, and we roughened the surface to create an anchor for the Belzona 1111; we formed a former of 2 and 3 inch , used Belzona release agent and applied the Belzona 1111 over the flanges
