# COATING AND REBUILDING MULTI-STAGE PUMP WITH BELZONA 1111 AND BELZONA 1341N

ID: 9752

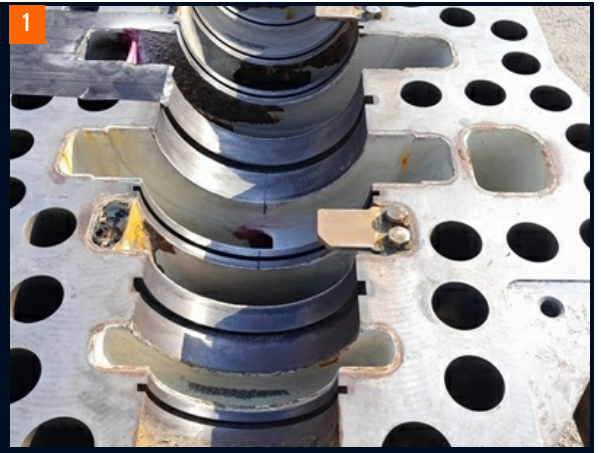
Multi-stage pump showed evidence of corrosion and erosion due to exposure to water.

1. Pump condition before application
2. Pump condition after blasting
3. Pump component coated with Belzona 1341N
4. Pit filling with Belzona 1111 and coated with Belzona 1341N for the pump
