# BELZONA REPAIRS SPLIT CASE PUMP

ID: 9753

Pump supplier required a coating for the internals of an old split case pump placed at a Desalination plant, during a refurbishment.

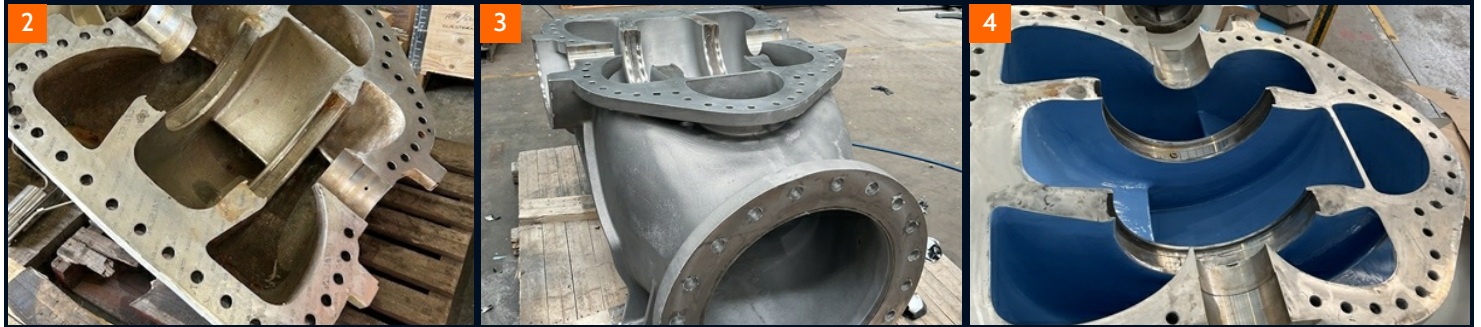
1. Split case pump prior to application.
2. Internal split case pump prior to application
3. Pump casing abrasive blasted, ready for Belzona coating.
4. Belzona 1341 (Supermetalgilde) coating carried out.

Pump was received into our workshop. Surface prep and clean carried out and an internal coating using Belzona 1341 (Supermetalgilde). External of the pump was coated in a 2 pac paint as per customers specification.
