# BELZONA SOLUTION FOR REFURBISHMENT OF PUMP CASINGS

ID: 9755

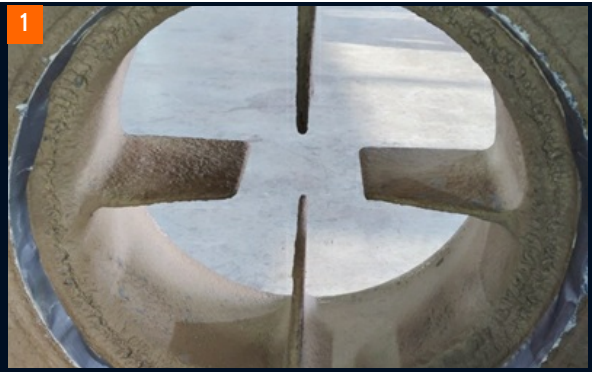
A power station customer is experiencing severe corrosion and material loss in their potable water centrifugal pumps, which are critical for water displacement circulation. This deterioration is driving up maintenance costs, reducing efficiency, and causing unexpected downtime. To restore performance and ensure long-term reliability, the customer requires a durable solution to mitigate corrosion and extend the equipment's service life.

1. Severe corrosion and material loss in centrifugal pumps.
2. Surface was grit blasted to achieve the required profile.
3. Application of Belzona 1121 for a strong, long-lasting restoration.
4. The surface was coated with 2 coats of Belzona 1341.
