# BELZONA CHOCKING SYSTEM INSTALLED AT A PAPERMILL

ID: 9758

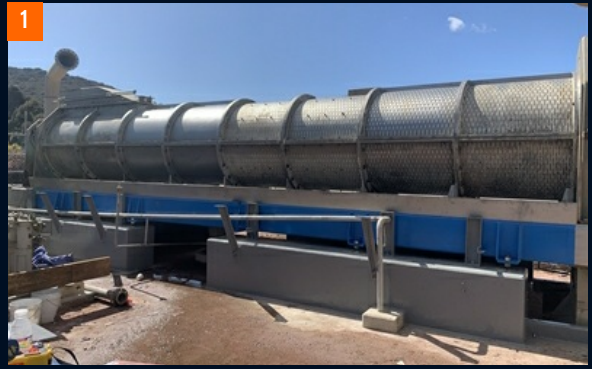
A 22-ton screw press with 16 support legs requires a chocking system to withstand harsh physical vibrations and thermal shock.

1. Screw press requires a high-performance chocking at the support legs to ensure stability and minimize vibrations
2. Formwork was built around the support legs before pouring the Belzona chocking system
3. Pouring Belzona 7111
4. Completed application of Belzona 7111, 100% solids chocking/grouting material
