# BELZONA SOLUTION FOR REBUILDING & COATING OF STRUCTURE OF VESSEL'S HATCHES

ID: 9759

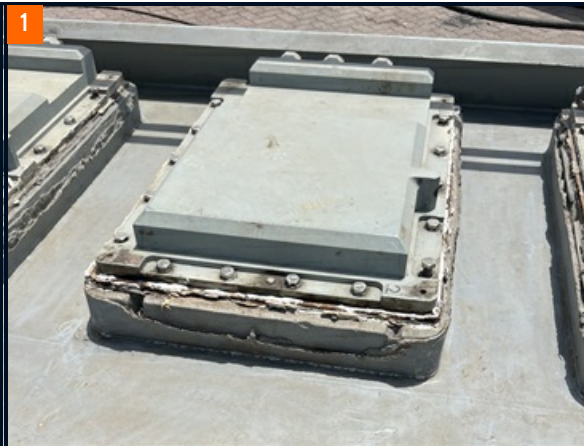
The vessel's hatch structures suffered severe corrosion due to prolonged exposure to seawater and the harsh marine environment. This deterioration significantly affected operational efficiency, complicating the assembly and disassembly processes and preventing the proper closure of the hatch covers. Urgent intervention was necessary to prevent further structural damage and restore functionality.

1. The vessel's hatch structures suffered severe corrosion due to prolonged exposure to seawater and the harsh marine environment.
2. The surface was manually prepared to achieve the required profile s hot work was not permitted.
3. The damaged area was then rebuilt using Belzona 1161, a surface-tolerant material, ensuring strong adhesion and a durable repair.
4. Finally, two coats of Belzona 1321 (Ceramic S-Metal) were applied, following the Belzona application procedure (IFU), to deliver superior protection and long-term performance.
