# BELZONA SOLUTION FOR REBUILDING AND COATING OF GLOBE VALVE

ID: 9760

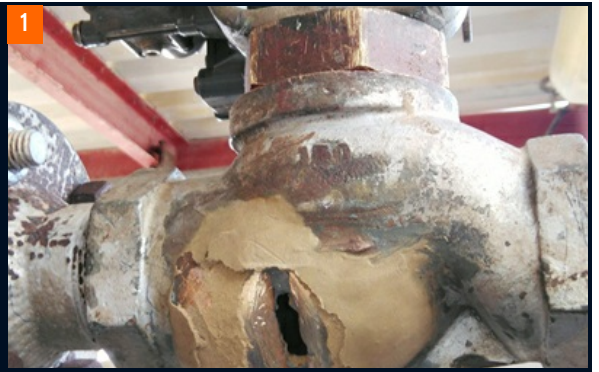
An offshore customer faced an issue with a globe valve that had developed a hole, leading to operational disruptions. To minimize downtime, they required an immediate solution to restore normal operations.

1. Globe valve that had developed a hole, leading to operational disruptions.
2. After thorough cleaning, the surface was grit blasted to achieve the required profile. Belzona 1111 was first applied for rebuilding.
3. Belzona 9341 was applied to reinforce the material, followed by an additional layer of Belzona 1111 (Super Metal) to further rebuild the surface.
4. Finally, two coats of Belzona 1321 (Ceramic S-Metal) were applied, following the Belzona Instruction for Use to provide superior protection and long-term performance.
