# BELZONA HELPS TO REBUILDING AND COATING THE CHILLER WITH 1111 AND 1321

ID: 9763

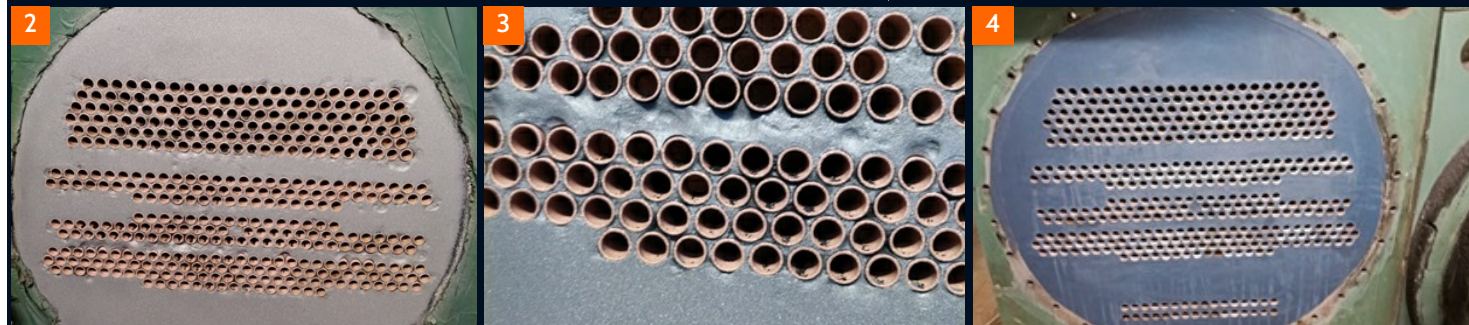
The customer was experiencing corrosion and erosion on the tube sheet, waterbox, and covers. The previously applied coating was unsuitable for the operating environment and failed to prevent damage. As a result, the customer sought a durable coating solution capable of withstanding corrosion and erosion while repairing internal tube damage without the need for welding.

1. Tubesheet face before blasting and coating
2. Tubesheet face after blasting
3. After blasting, significant metal loss was evident on the tubesheet face, requiring rebuilding with Belzona 1111
4. Final stage after Belzona rebuilding and coating

We began by blasting the surface with coal slag grit to achieve a minimum 75 µm profile and near white metal cleanliness. Next, we rebuilt the surface using Belzona 1111 (Super Metal) to fill in the pitting and repair the metal loss on the tubesheet face and covers. Finally, we applied two coats of Belzona 1321 (Ceramic S-Metal), each with a thickness of 375 µm, to achieve a total dry film thickness (DFT) of 750 µm.
